Mountain View Pool Evaluation

Friday, 08 September 2023

Prepared For City of Port Townsend

1919 Blaine Street, Port Townsend, WA 98368

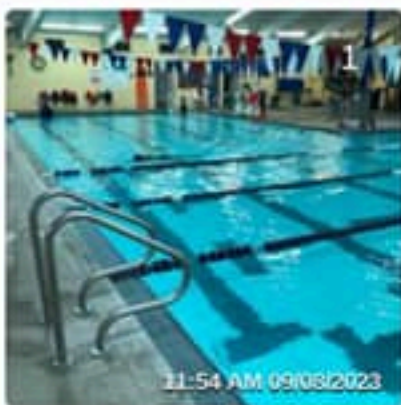
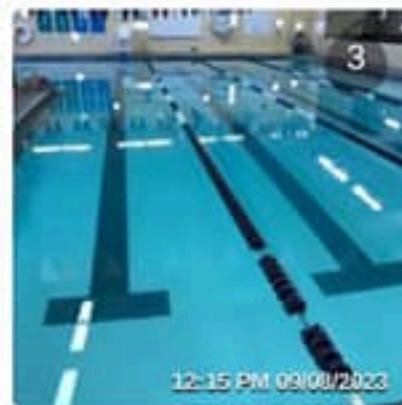
Pool vessel is constructed of concrete. Staff reports leaking and significant water loss, particularly versus the previous year.

Significant efflorescence exists in the subgrade spaces of the outside of the pool vessel, indicative of moisture penetration through the pool vessel. Moisture has the potential to weaken the structural integrity of the concrete. Replacement of significant portions of the pool vessel are likely necessary within the next few years.

- 1) Excessive moisture has penetrated the concrete pool vessel.
- 2) Pool liner is rippling/bubbling and leaking.
- 3) Perimeter gutter is an ineffective surface skimming method.

- **Replace Pool Liner**
Replacement of the interior pool liner with a quartz aggregate plaster finish
- **Repair Pool Vessel**
Inspection of pool vessel concrete with liner removed; repair/seal of all cracks and replacement of any area with spalling/deterioration of concrete.
- **Replace Pool Gutter**
Replacement of the existing perimeter gutter with a deck level gutter with trench and PVC grating. Also involves installation of new lane divider anchors.
- **Refinish Pool Deck**
Refinish pool deck with textured sealant or topical coating.
- **Replace Failed Deck Drains**

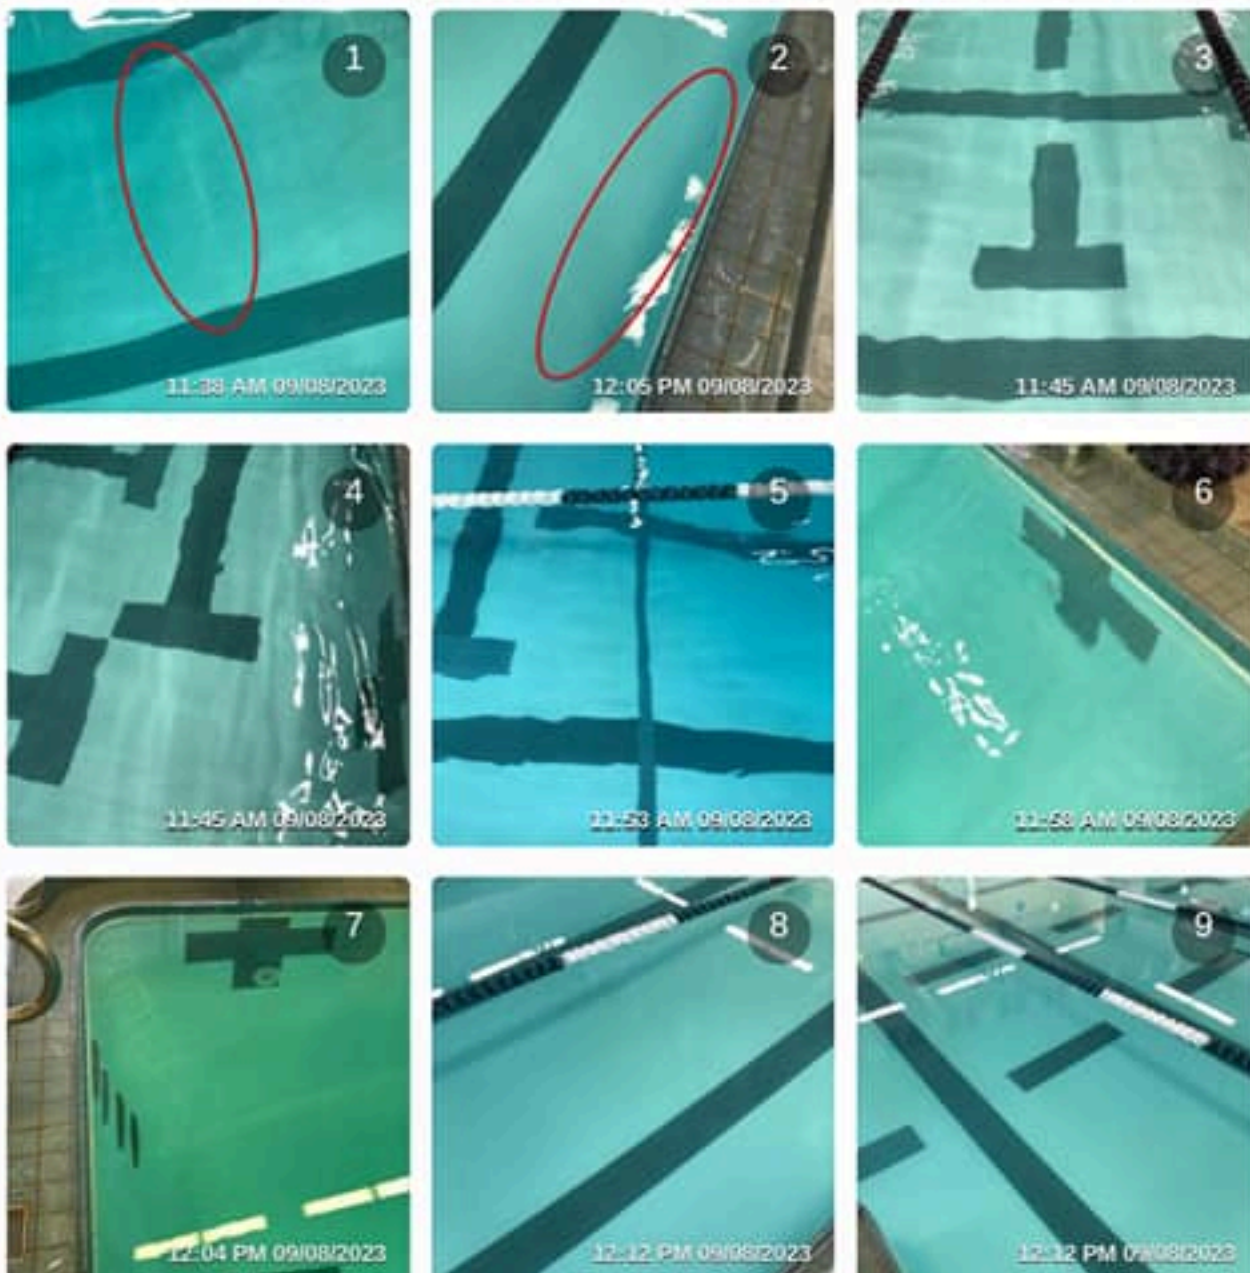
The interior of the pool is finished with a PVC liner. Several locations of the liner are rippling or bubbling, such as indicated in Images 1 and 2. Rippling or bubbling could indicate water under the liner and/or areas of leaking, particularly when at seams in the liner. Areas of rippling or bubbling will only continue to worsen if not repaired. The pool liner should be removed for replacement as well as further inspection of the interior of the pool vessel concrete.

The top of the liner is adhered to the pool vessel with a thick band of "rubber", which is peeling off in at least one location.

Lane line markings, on the walls and floor, as well as floor slope transition markings, appear to be vinyl strips adhered to the liner. Slight deterioration can be seen on the lane line markings but are overall in good condition.

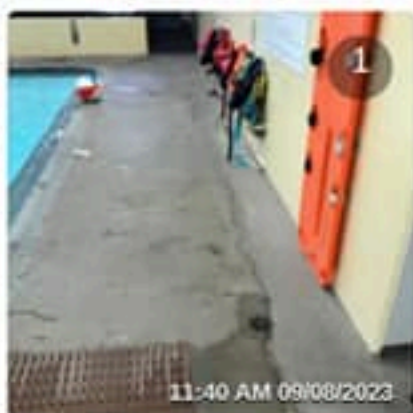
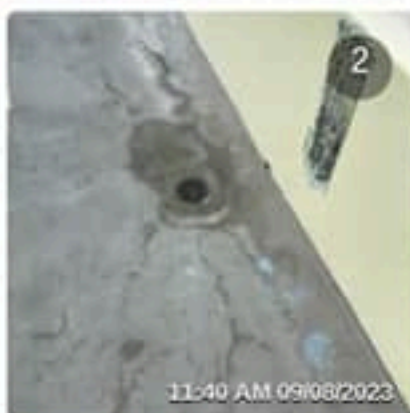
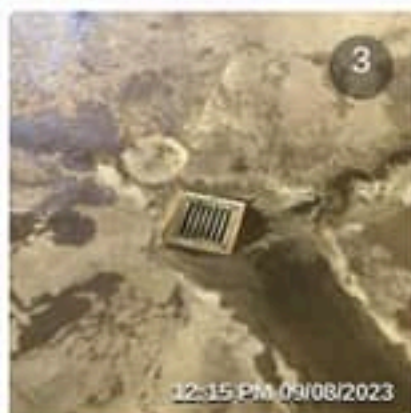
Surface coating delaminating in some locations

Extremely slippery in some high traffic areas; insufficient coefficient of friction suspected.

Spot drains, not sufficiently removing water from deck, areas remain wet.

Two drains near locker room entrance observed to be clogged / no operating

- 4) Pool deck coating is delaminating.
- 5) Pool deck is slippery and has poor coefficient of friction.
- 6) Deck drains fail to drain water sufficiently.

- Replace non-functioning deck drains and drain piping.
- Replace Starting Platforms
Replace all starting platforms and platform anchors.
- Replace Main Drains
Replace main drain sumps, gratings, and piping.

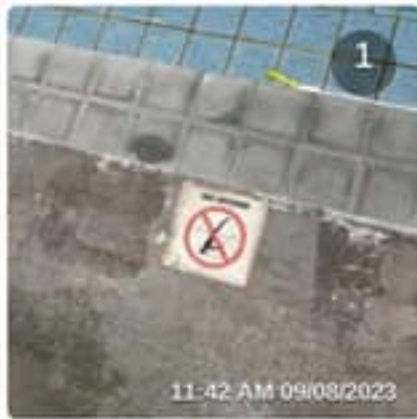
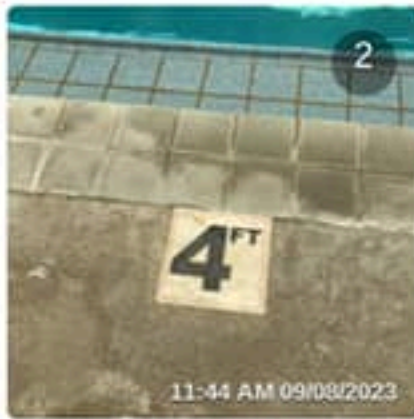
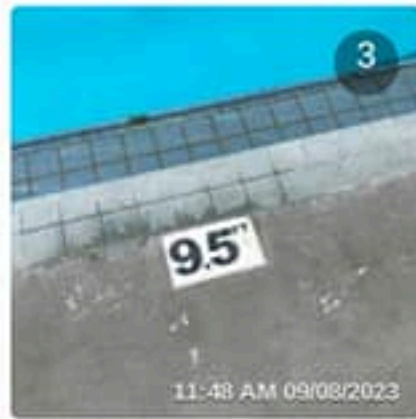
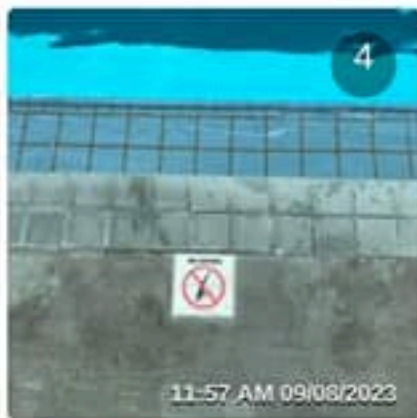
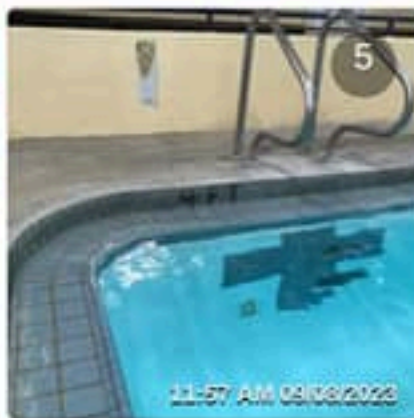
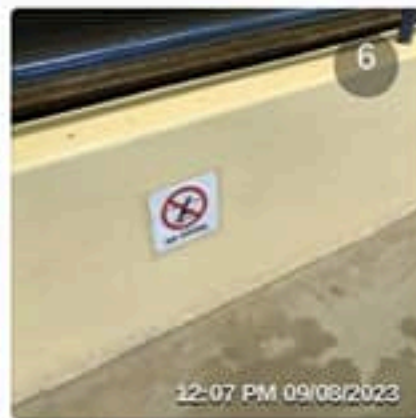
Horizontal depth markers are laminate tiles on the concrete pool deck

Vertical depth markers are 1x1 tiles at the back of the gutter shelf

Depth markers do not exist at all deviations in floor slope as per code

- 7) Additional depth markers are needed at floor slope transitions.
- 8) Lane dividers across gutter create a tripping hazard.
- 9) Excessive corrosion on starting platforms

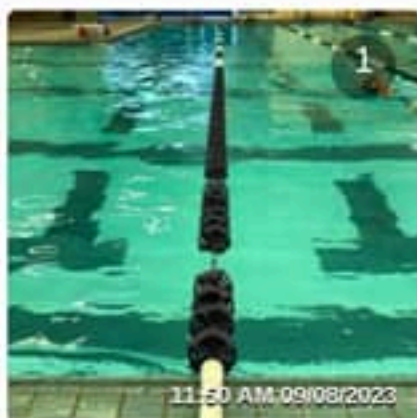
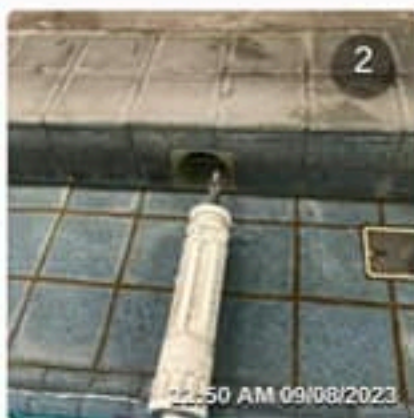
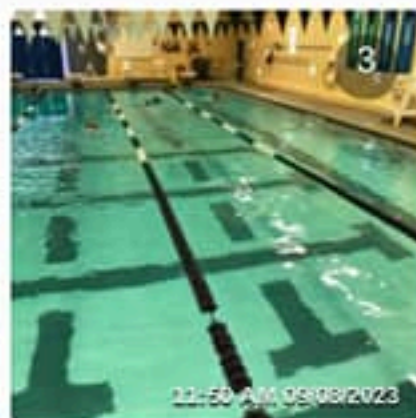
Lane dividers are attached to anchors at the back of the gutter shelf, creating a tripping hazard for anyone using the gutter shelf as a step or access point.

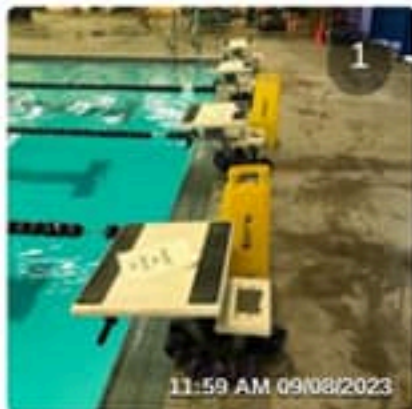
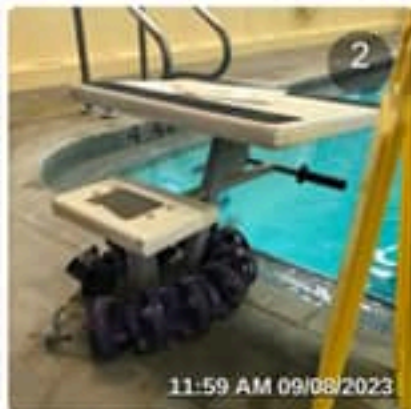
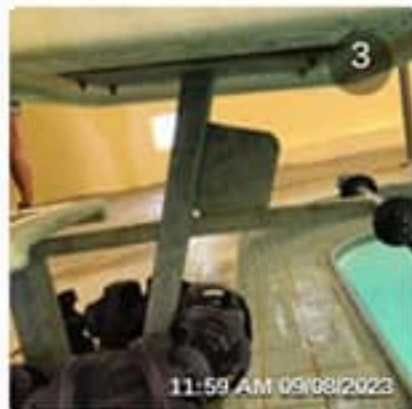
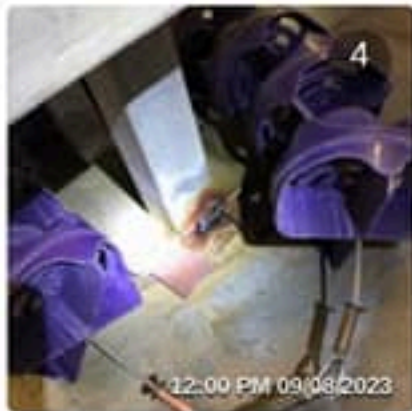
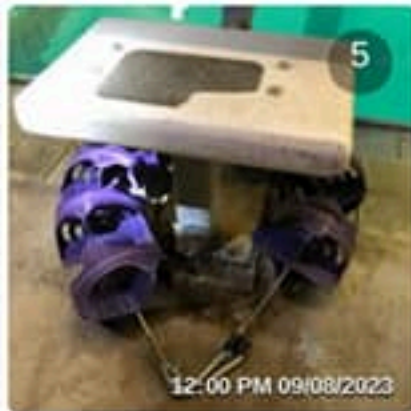
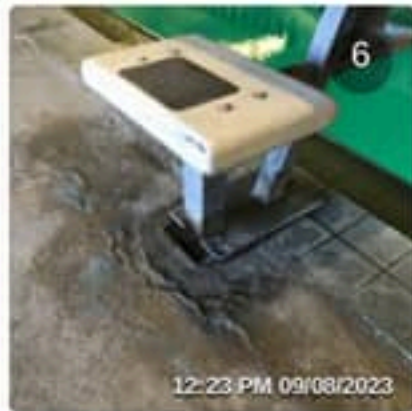
Stand support and particularly anchors are severely corroded

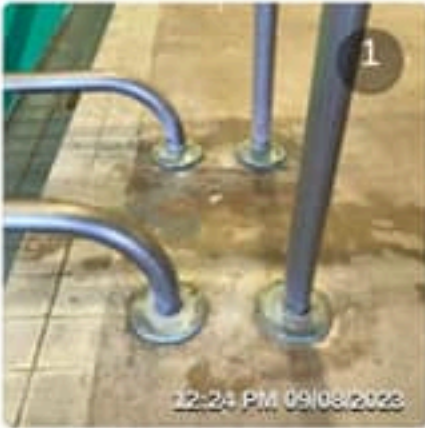
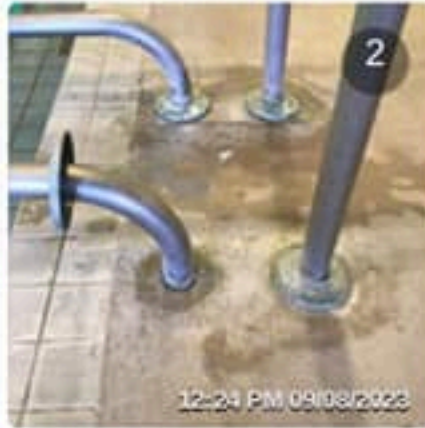
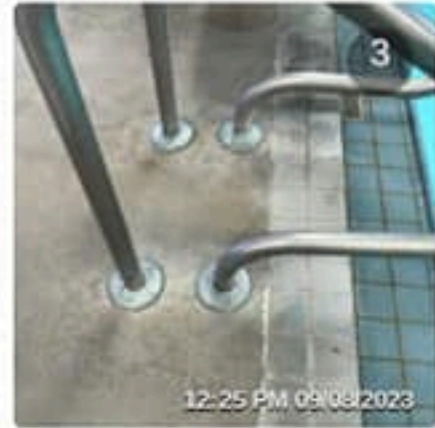
Stainless steel hardware around the pool, such as ladder handrails had medium levels of

scale formation.

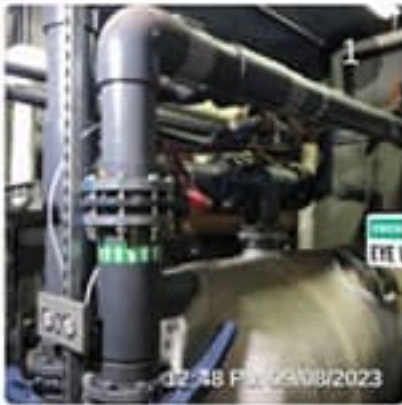
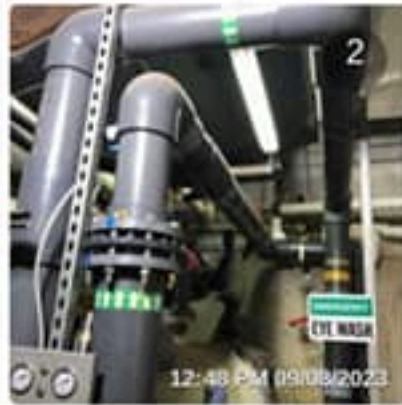
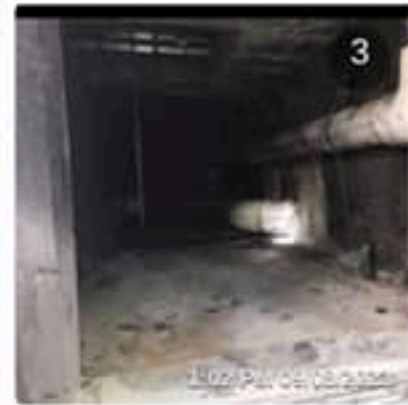
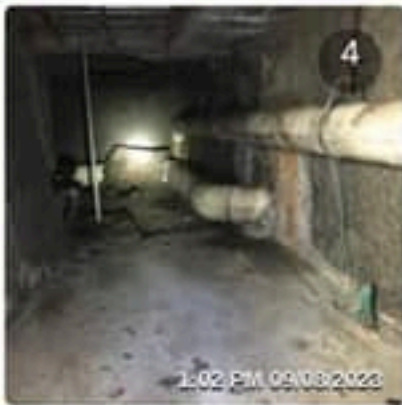
Piping in mechanical room is schedule 80 pvc and appears in good condition. Piping is well labeled.

In the subgrade mechanical chase, pipe hangers are badly corroded, and leaking water is visible.

- 10) Main drains are not functioning.
- 11) Bulb replacement is needed on two overhead lighting fixtures.
- 12) Piping hangers in subgrade mechanical chase are severely corroded.

- Replace Pipe Hangers
Replace all corroded pipe hangers.
- Install Additional Air Returns/Exhaust
Install low level air returns and/or source capture chloramine exhaust in the deck or gutter

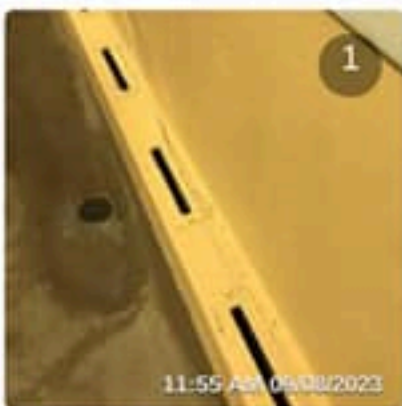
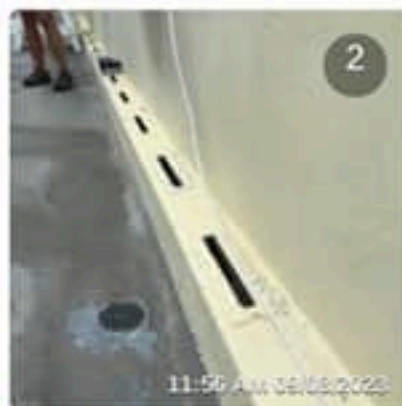
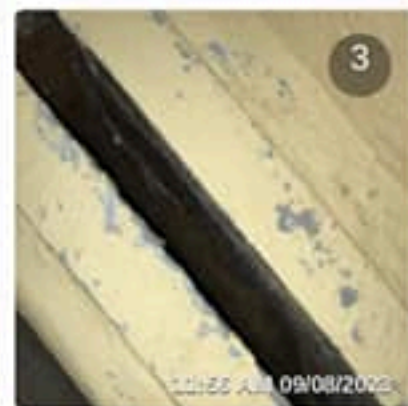
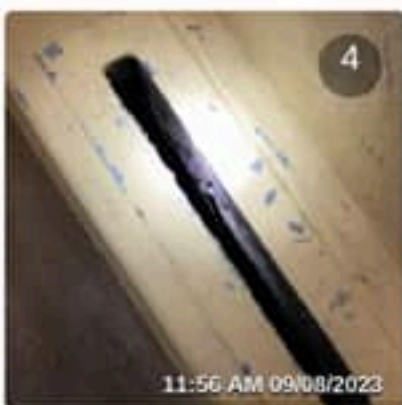
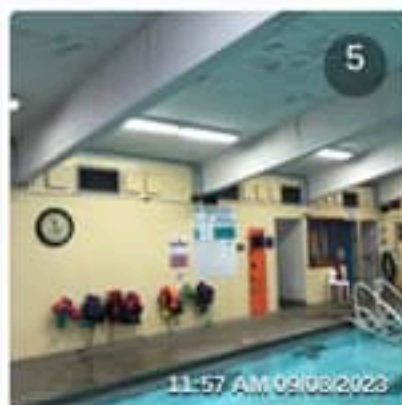
Natatorium HVAC air distribution is generally insufficient. Air is returned to the natatorium at low, floor level locations. Air is removed from the natatorium at high, ceiling level locations; the opposite of a properly distributed natatorium. Air needs to be evacuated from the natatorium at low deck/water levels to properly remove gases and other contaminants discharged from the pool water and remaining on or about the water surface.

- 13) HVAC air distribution is insufficient and lacks low level return.
- 14) Circulation pump is installed above grade and lacks a Variable Frequency Drive

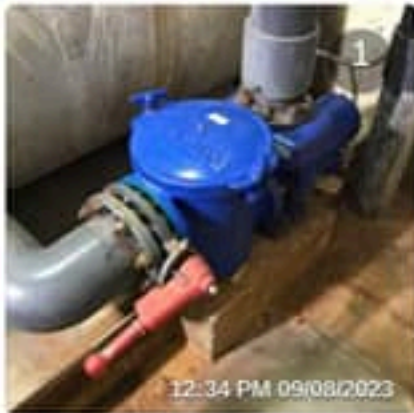
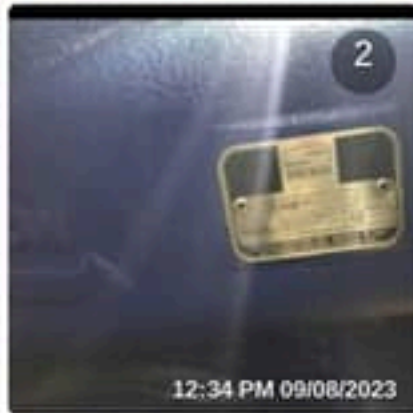
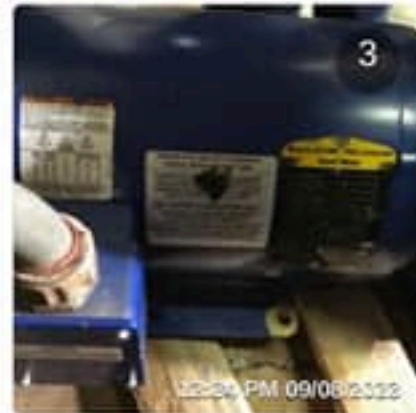
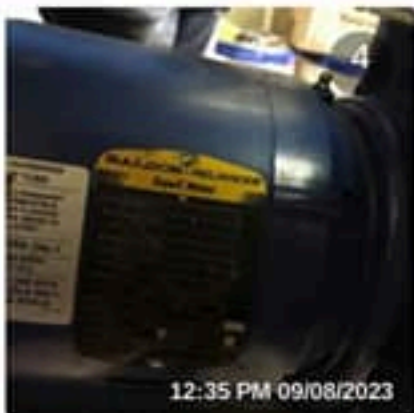
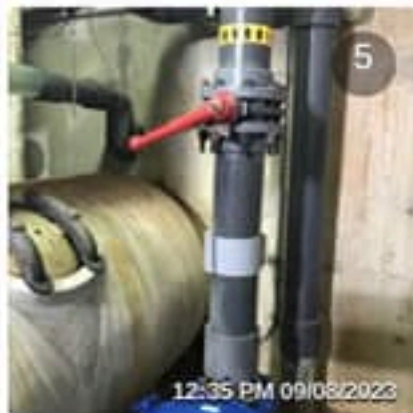
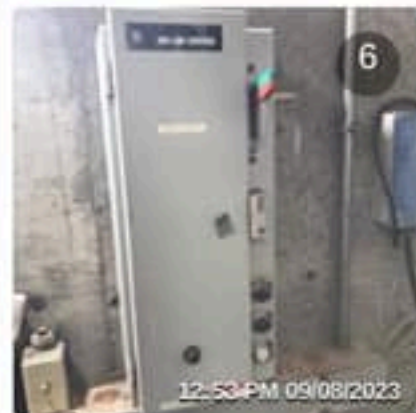
Pool water is circulated with a single 7.5 HP pump. The piping before and after the pump is partially "throttled" or closed with valves to prevent the water flowing at a faster rate than desired. This is very inefficient as the pump is running at full power and the water is mechanically block. A variable frequency drive could adjust the pump motor to run at the desired output, thus saving significant energy usage. Furthermore, the pump is a flooded suction pump installed in a non-flooded, self-priming condition. This makes starting the pump difficult and pump operating less efficient.

- Install VFD
Install a Variable Frequency Drive on the circulation pump.
- Construct Separate Chemical Room
Construct a separate chlorine storage room from calcium hypochlorite storage and feed system location with proper spill containment.

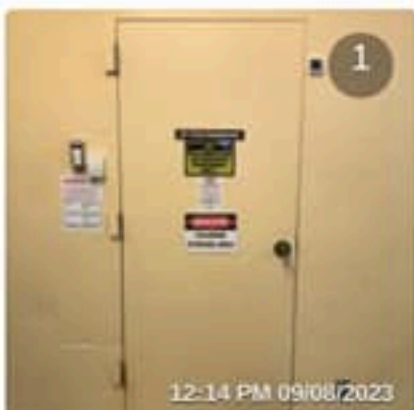
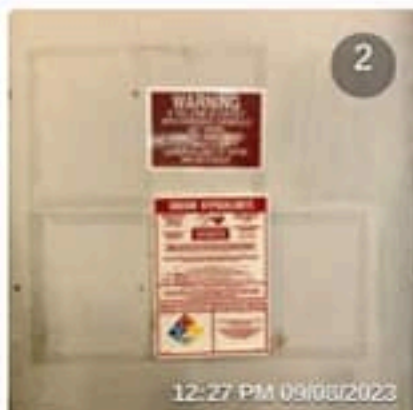
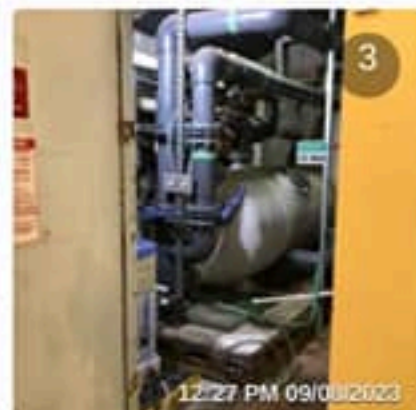
Chemicals and water treatment equipment are all comingled in the general mechanical room. Calcium Hypochlorite was present along with other common pool chemicals. There are no floor drains in this space. Metal door frames and hardware are significantly corroded in this room. Low level mechanical air venting is present.

- 15) Chemicals storage lacks separation of hazardous compounds.
- 16) Surge tank concrete is deteriorating.
- 17) Pool heat exchanger is excessively corroded.

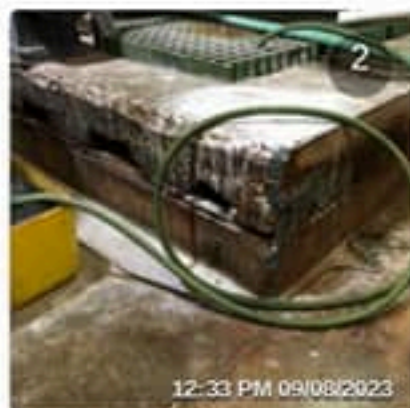
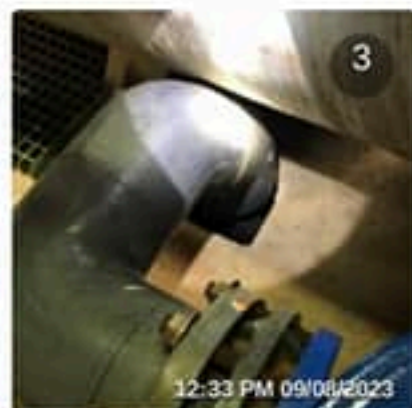
Water from the pool gutters is conveyed to a surge tank in the mechanical room. The surge tank has open venting to the mechanical room, thus allowing corrosive humidity and chloramines from the pool water to enter the mechanical room. The concrete top of the surge tank is badly deteriorated with exposed and corroded rebar.

- Install Ultraviolet
Install an ultraviolet disinfection system for chloramine reduction and additional pathogen protection.
- Repair Surge Tank
Repair deteriorating concrete on surge tank.

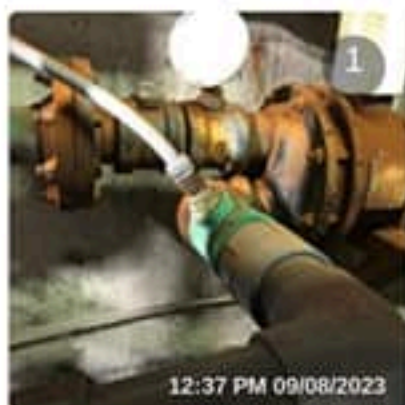
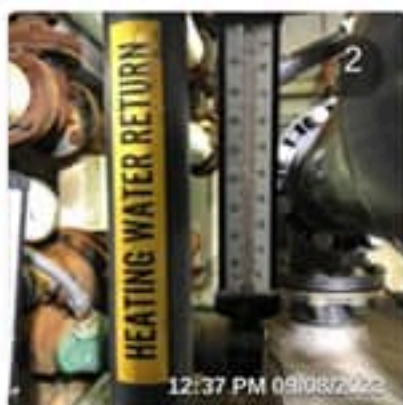
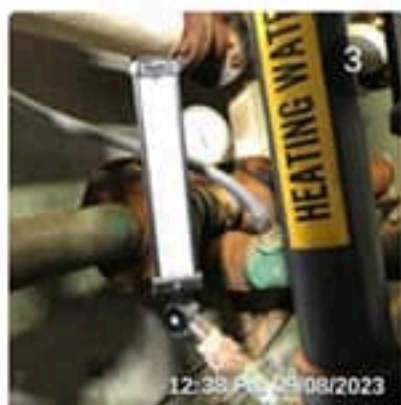
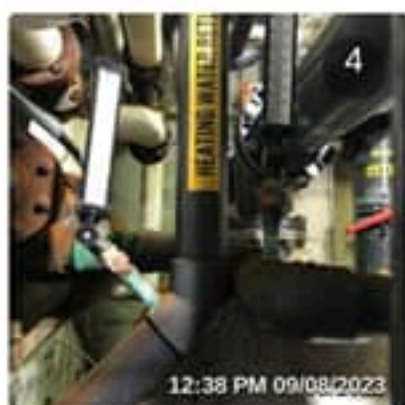
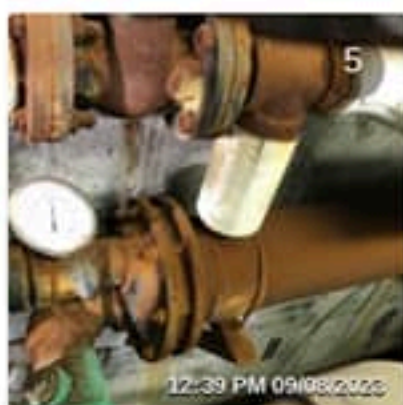
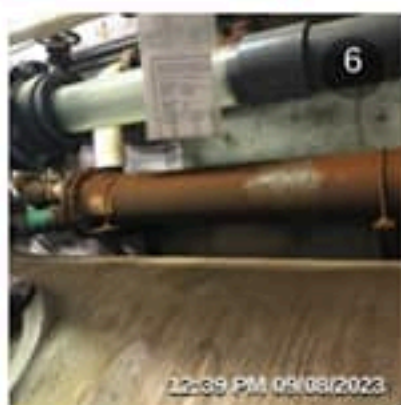
The pool water is heated via the building boiler system with a tube heat exchanger located in the pool mechanical room. The heat exchanger and associated piping and valving is badly corroded.

- Replace Heat Exchanger
Replace pool heat exchanger and associated piping.
