civil & structural
engineering & planning

STRUCTURAL ASSESSMENT REPORT

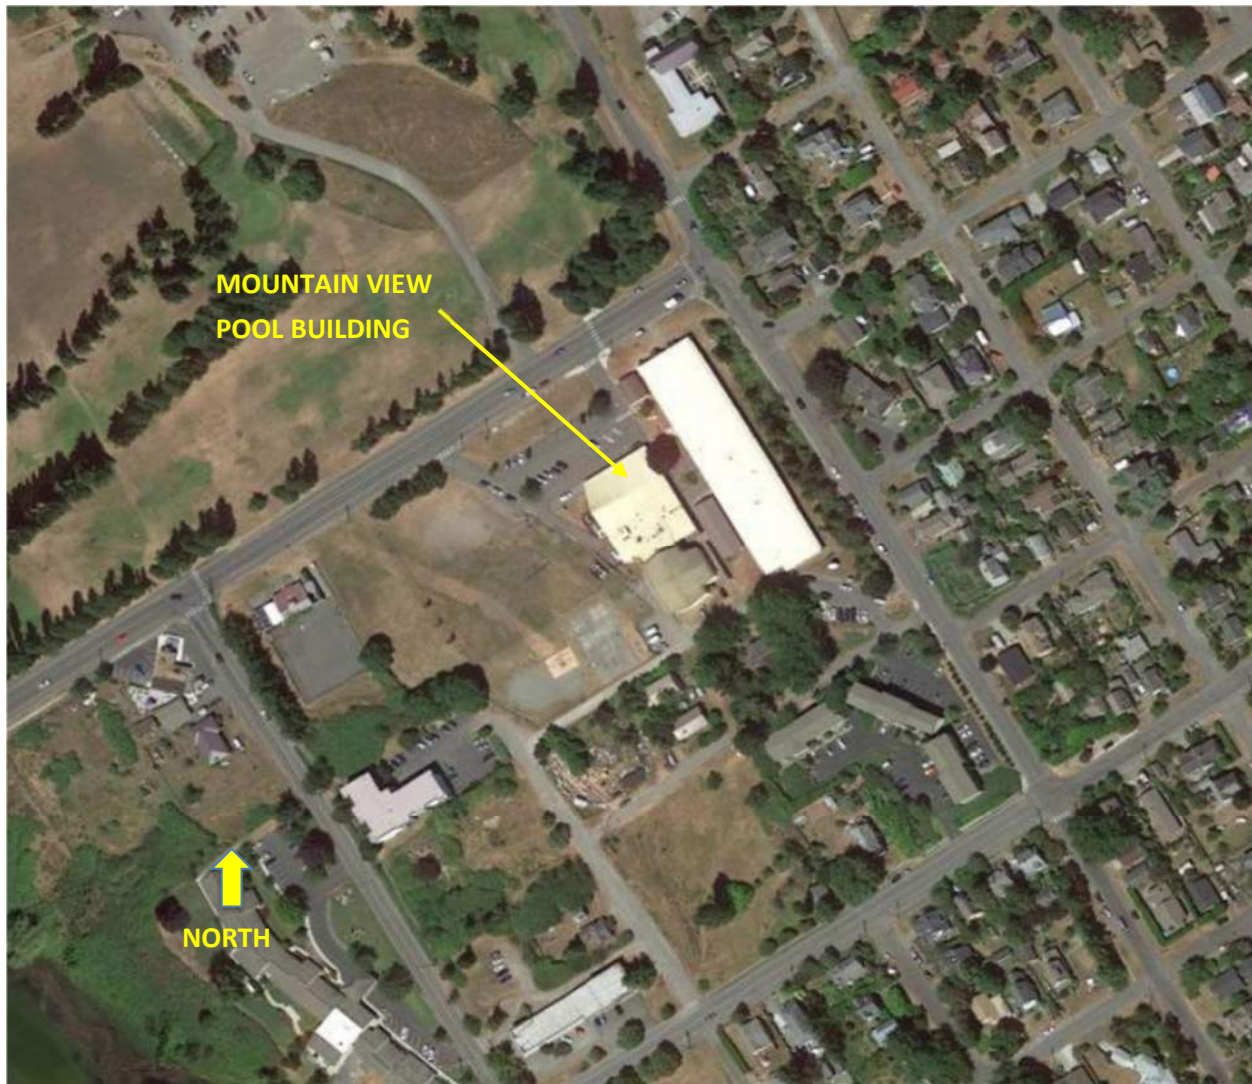
Our findings are summarized in this report. Our observations and recommendations are limited to areas of the structure that were visible and accessible. Destructive investigations and tests were not carried out as a part of this assessment. Our observations were limited to the structure itself and did not include any observations of architectural components or MEP systems.

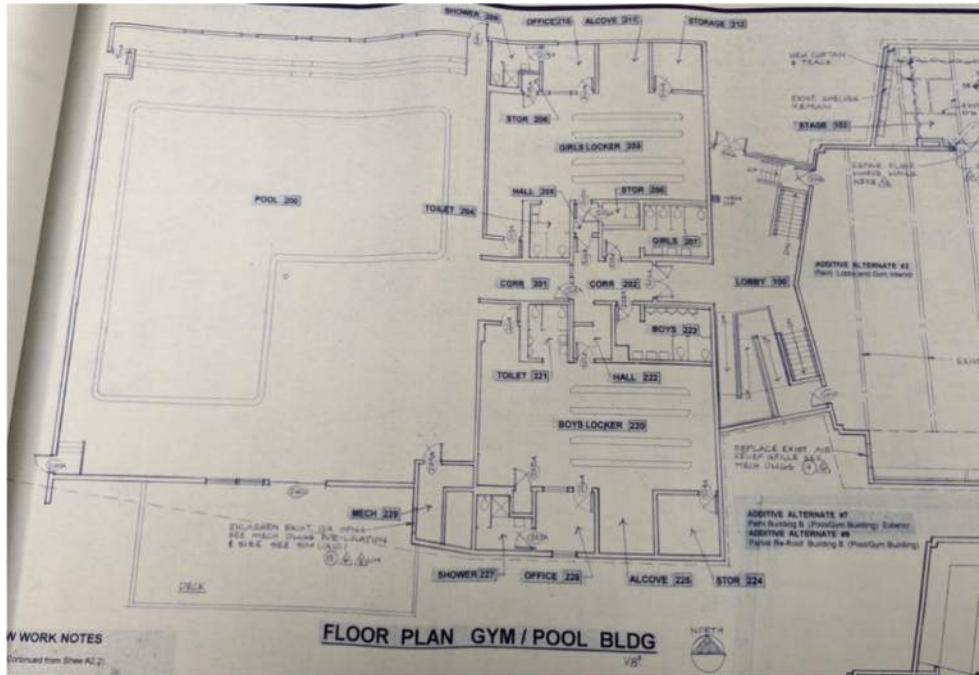
EXISTING FLOOR PLANS

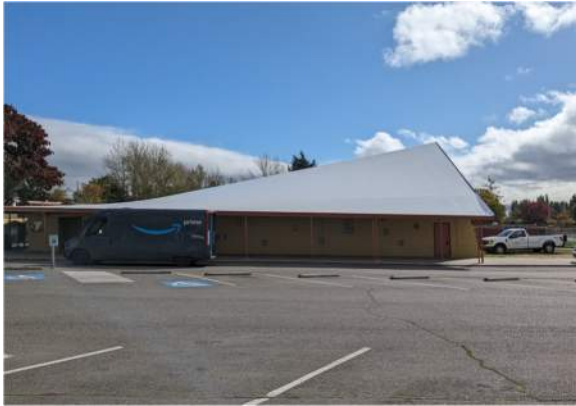
Overall Building View Looking Southeast

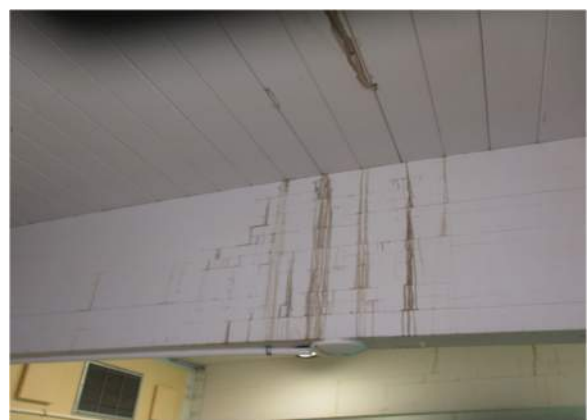
Typical Water Staining on Glulam Beam/Purlin and T&G Decking

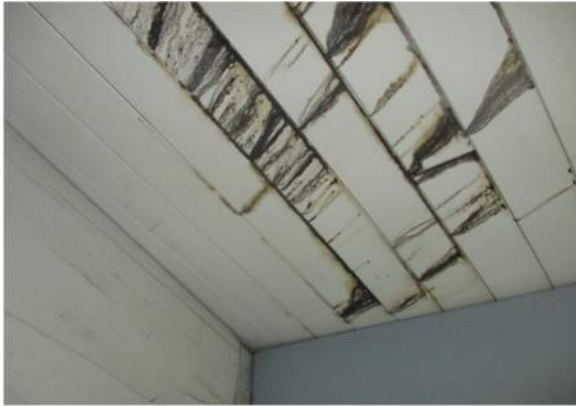
Water Staining at Western Ridge Beam End

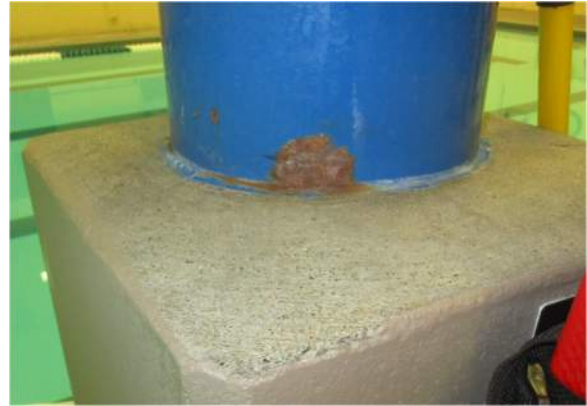
Rust at Base of 8" \varnothing Pipe Column

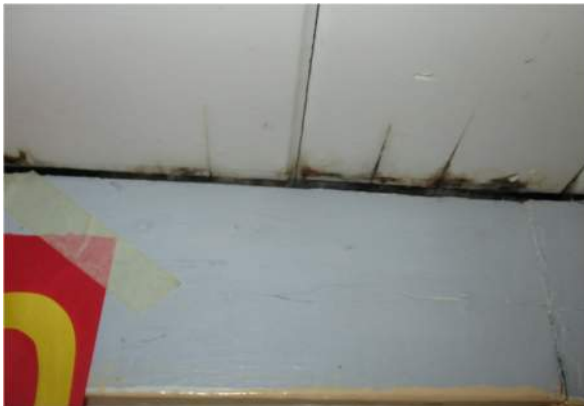
T&G Decking Water Staining at Eastern Wall

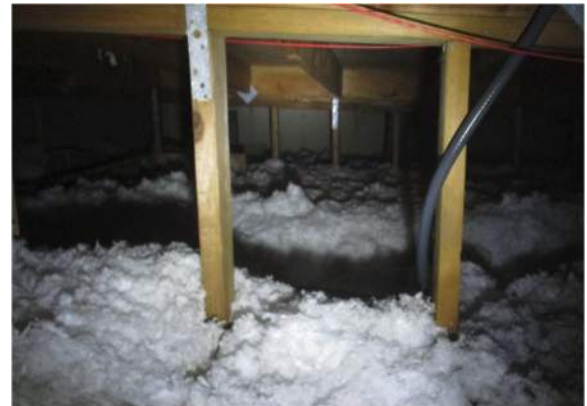
Roof Framing in Attic Space Above Lobby

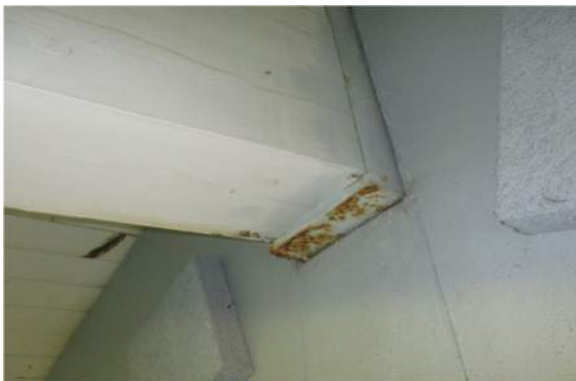
Superficial Rusting on Ridge Beam Hanger at West Wall

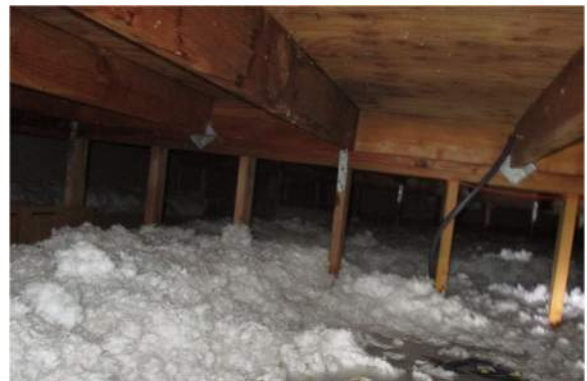
Roof Framing in Attic Space Above Lobby

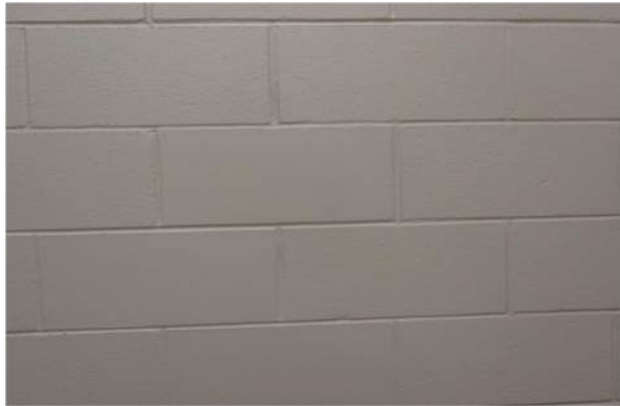
Minor Stair-step Mortar Crack in Men's Locker Room CMU Wall

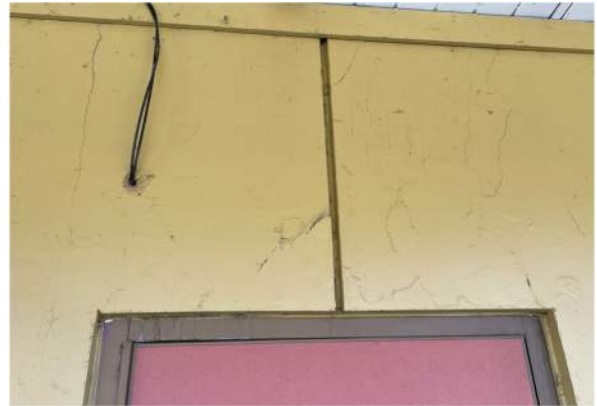
Temperature Cracking over Northeast Exit Door (Exterior)

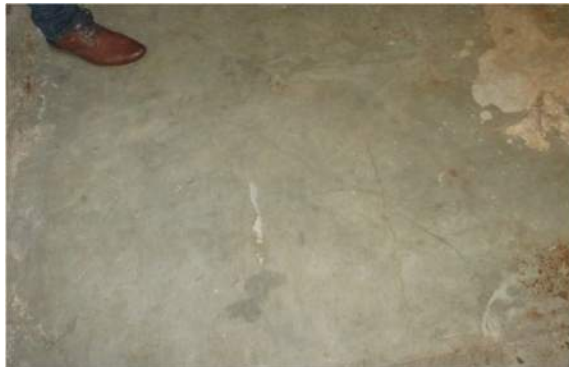
Minor Crack in Men's Locker Room Floor Slab

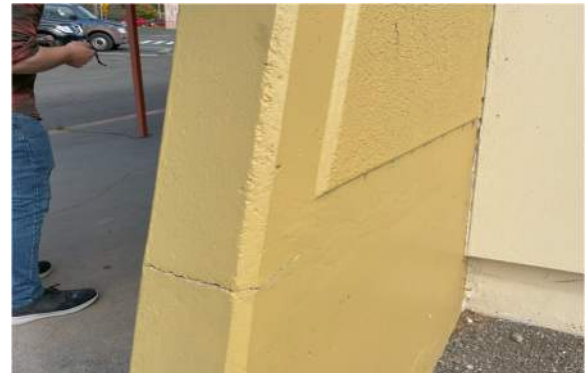
Cracking at Northwest Corner of Pool Building

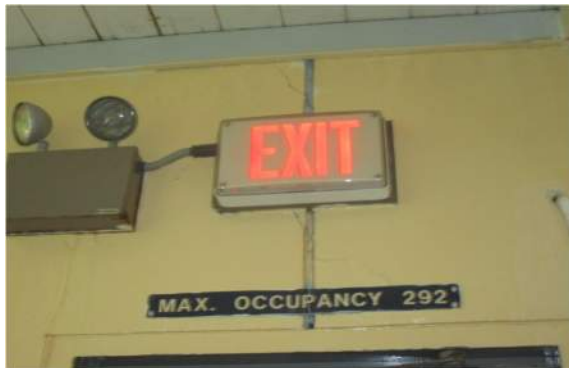
Temperature Cracking over Northeast Exit Door (Interior)

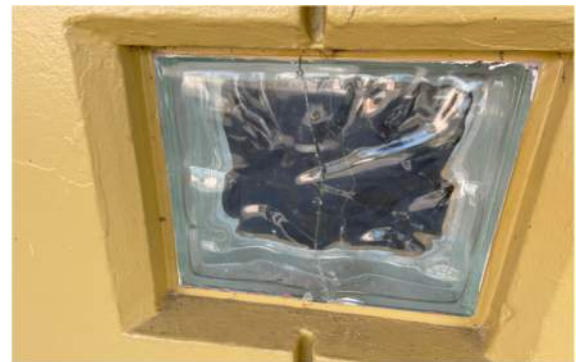
Cracked Glass Block Window at Eastern Wall

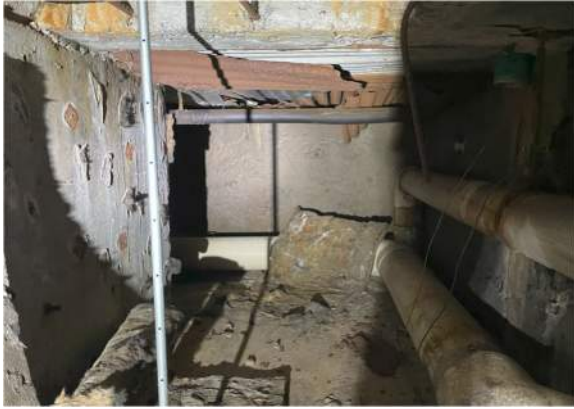
Northwest Ventilation Tunnel Looking Northeast

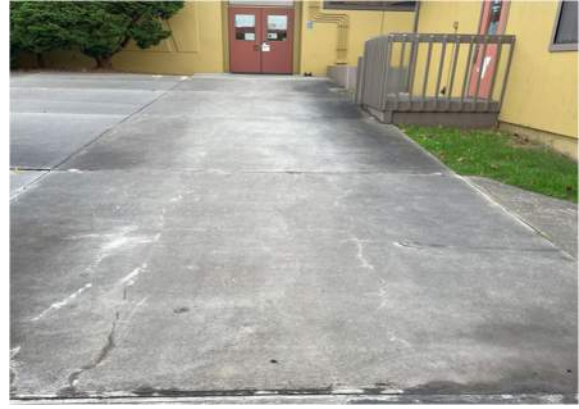
Cracking in Slab Above Mechanical Room Ventilation Tunnel

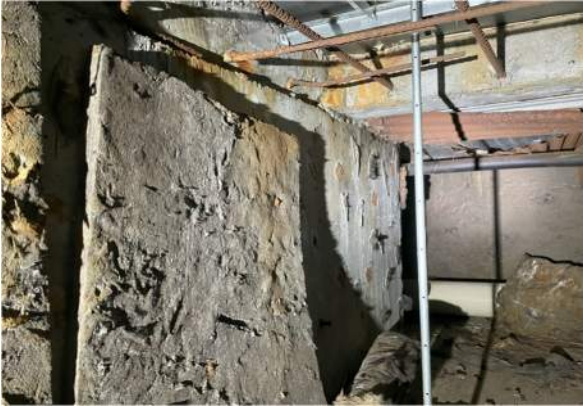
Exposed Rebar in Northwest Ventilation Tunnel

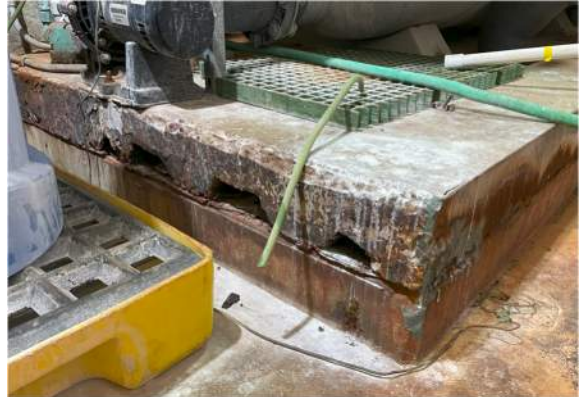
Pool Room Equipment Pad with Corroded Metal Deck and Spalling Slab

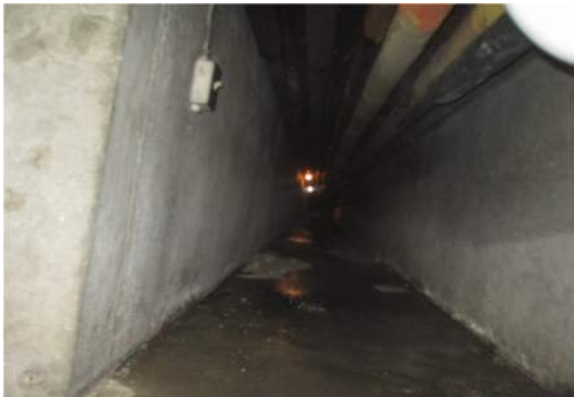
Mechanical Room Ventilation Tunnel Looking Northeast

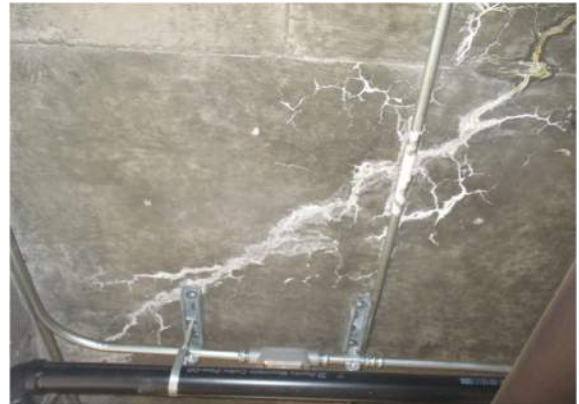
Cracking in Mechanical Room Ceiling Below Men's Locker Room
