Mountain View Pool Evaluation

Friday, 08 September 2023

Prepared For City of Port Townsend

1919 Blaine Street, Port Townsend, WA 98368

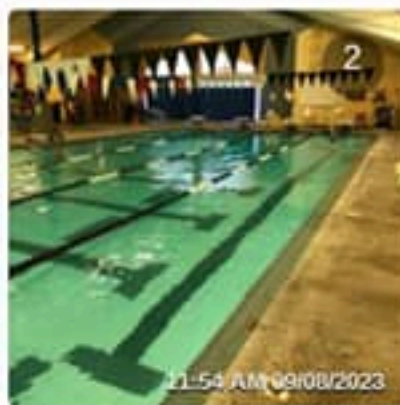
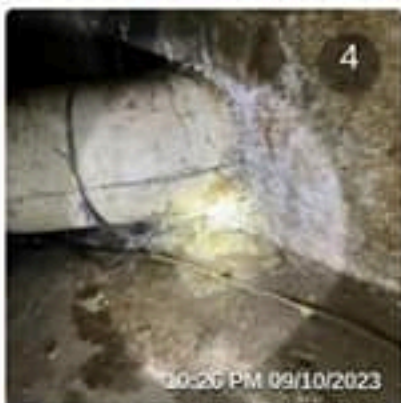
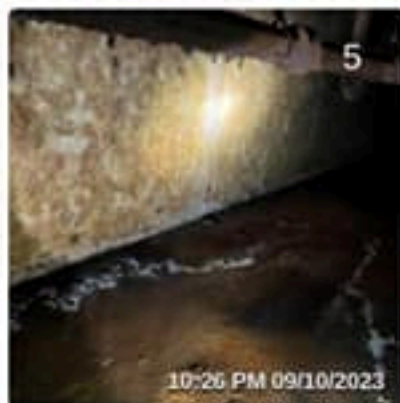
The interior of the pool is finished with a PVC liner. Several locations of the liner are rippling or bubbling, such as indicated in Images 1 and 2. Rippling or bubbling could indicate water under the liner and/or areas of leaking, particularly when at seams in the liner. Areas of rippling or bubbling will only continue to worsen if not repaired. The pool liner should be removed for replacement as well as further inspection of the interior of the pool vessel concrete.

- 1) Excessive moisture has penetrated the concrete pool vessel.
- 2) Pool liner is rippling/bubbling and leaking.
- 3) Perimeter gutter is an ineffective surface skimming method.

- **Replace Pool Liner**
Replacement of the interior pool liner with a quartz aggregate plaster finish
- **Repair Pool Vessel**
Inspection of pool vessel concrete with liner removed; repair/seal of all cracks and replacement of any area with spalling/deterioration of concrete.
- **Replace Pool Gutter**
Replacement of the existing perimeter gutter with a deck level gutter with trench and PVC grating. Also involves installation of new lane divider anchors.
- **Refinish Pool Deck**
Refinish pool deck with textured sealant or topical coating.
- **Replace Failed Deck Drains**

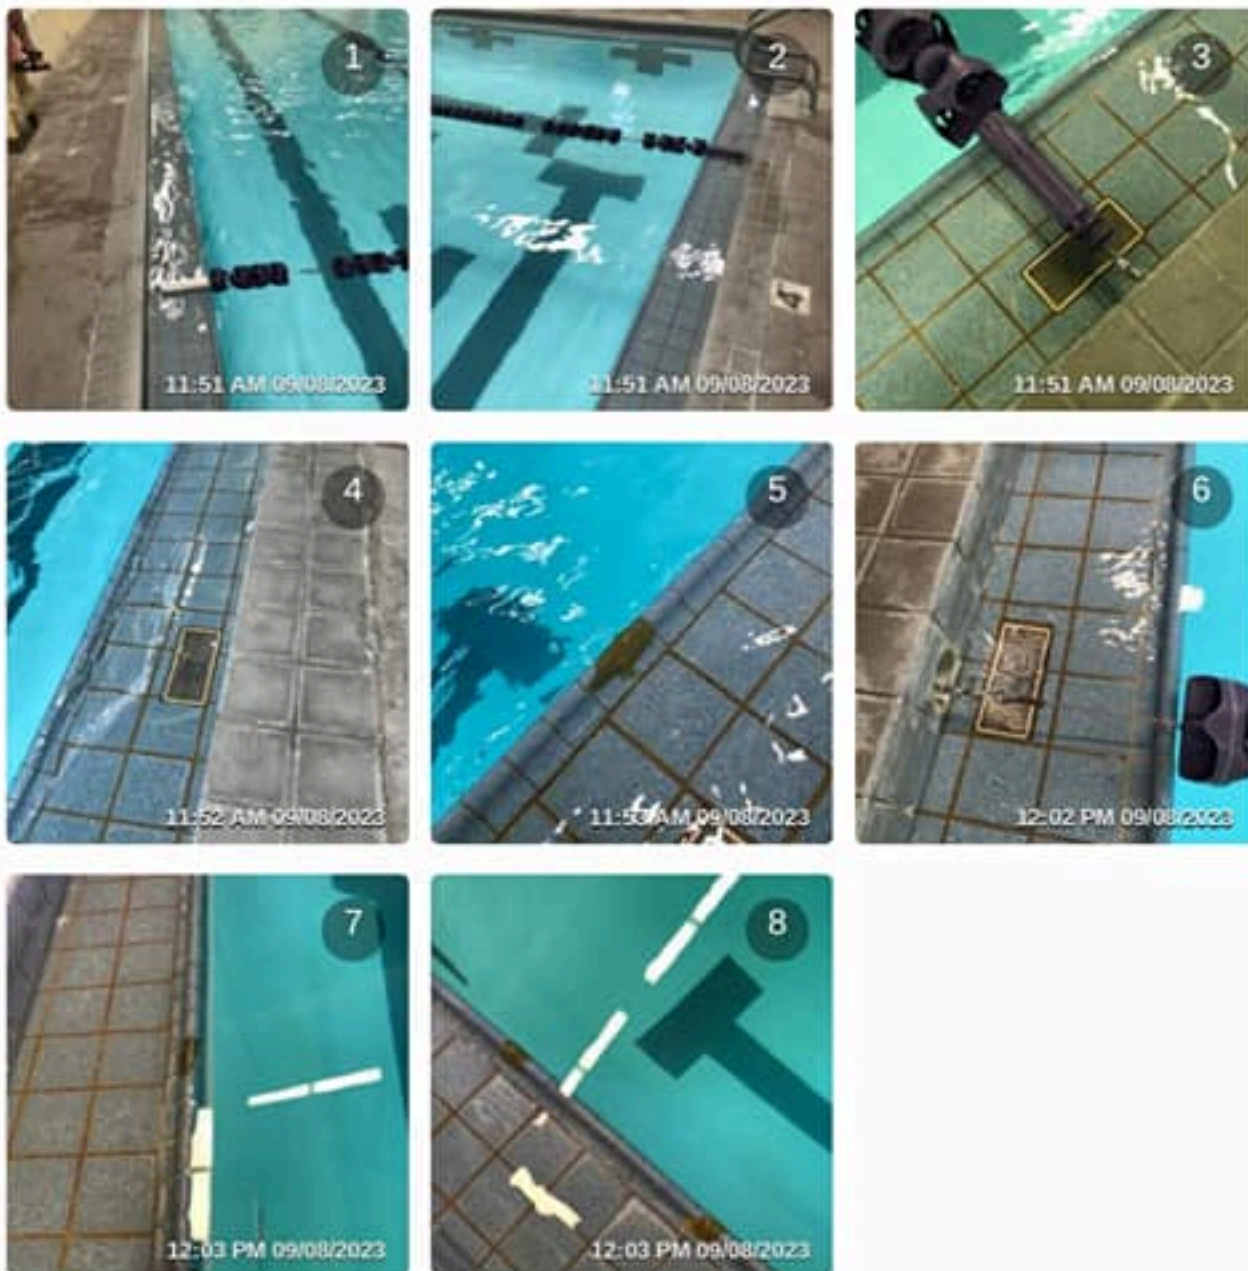
The perimeter of the pool is a trenchless rollout "gutter". This style of gutter is ineffective. The intent of any perimeter gutter is to skim the surface of the water along the entire perimeter to remove debris, oils, and other contaminants on the water surface. A small tile "lip" or handhold at the edge of the pool accomplishes the skimming action when the pool water is very calm. However, the gutter does not have a trench to gather and collect water. Therefore, any moderate user activity in the pool easily sends waves over the handhold edge and fills the gutter ledge with water, eliminating any skimming action. The small dropouts along this gutter ledge are insufficient in size and number to evacuate the water. This means anytime the pool has moderate activity the surface of the water is not being skimmed, and the dirtiest water in the pool is not being properly conveyed to the filtration system. Further aggravating this, some of the dropouts were not working and had little to no flow of water.

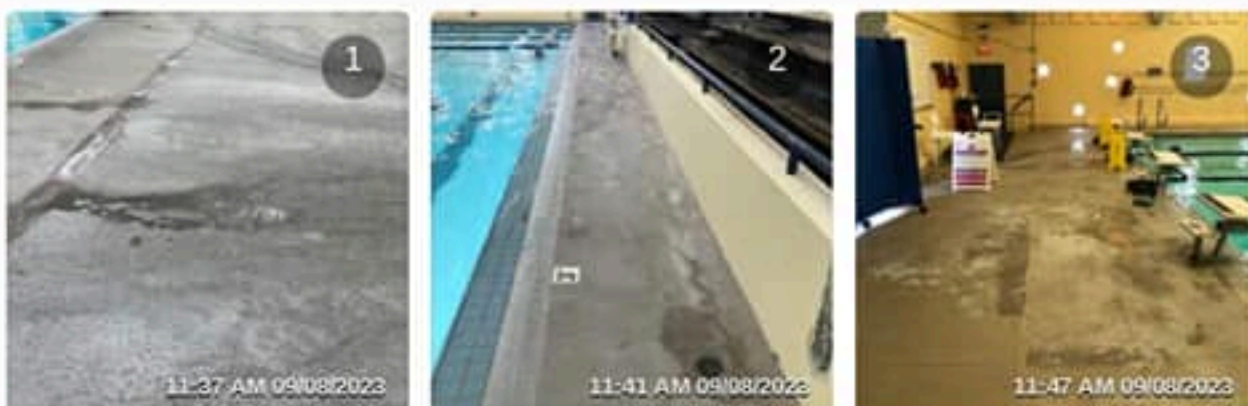
Surface coating delaminating in some locations

Extremely slippery in some high traffic areas; insufficient coefficient of friction suspected.

While deck dimensions meet code minimums, the deck is rather narrow on the north (4') and west (5') sides.

- 4) Pool deck coating is delaminating.
- 5) Pool deck is slippery and has poor coefficient of friction.
- 6) Deck drains fail to drain water sufficiently.

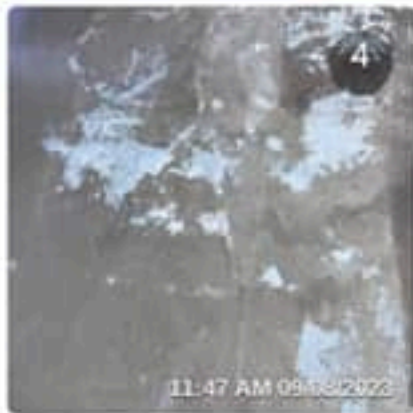
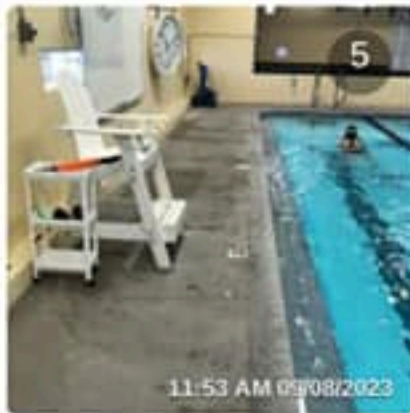
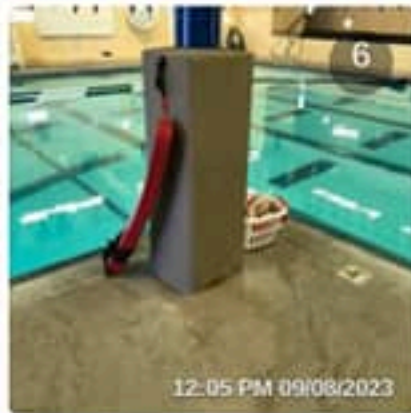
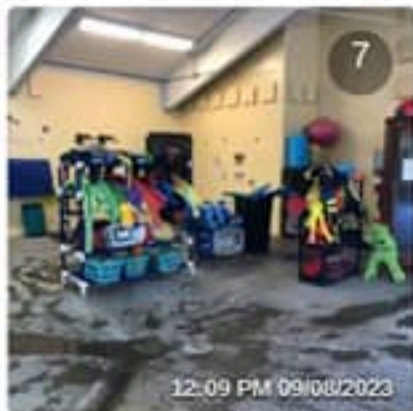
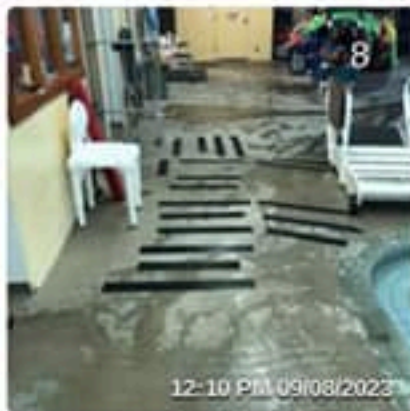
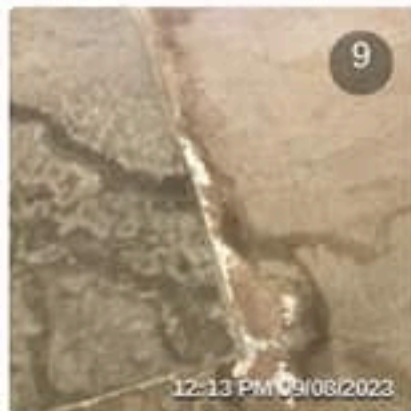
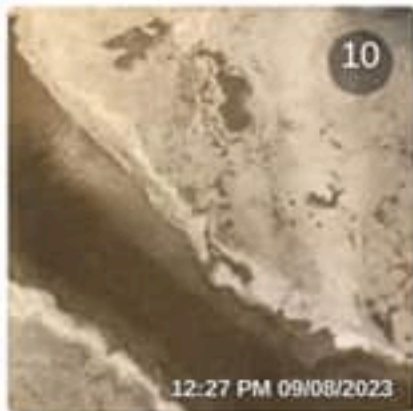
Spot drains, not sufficiently removing water from deck, areas remain wet.

Two drains near locker room entrance observed to be clogged / no operating

- Replace non-functioning deck drains and drain piping.
- Replace Starting Platforms
Replace all starting platforms and platform anchors.
- Replace Main Drains
Replace main drain sumps, gratings, and piping.

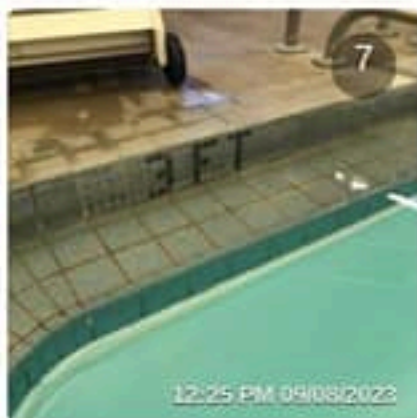
Horizontal depth markers are laminate tiles on the concrete pool deck

Vertical depth markers are 1x1 tiles at the back of the gutter shelf

Depth markers do not exist at all deviations in floor slope as per code

- 7) Additional depth markers are needed at floor slope transitions.
- 8) Lane dividers across gutter create a tripping hazard.
- 9) Excessive corrosion on starting platforms

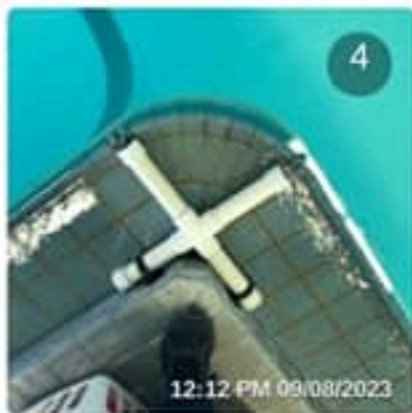
Lane dividers are attached to anchors at the back of the gutter shelf, creating a tripping hazard for anyone using the gutter shelf as a step or access point.

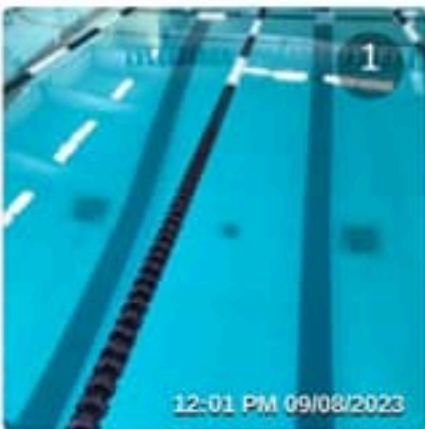
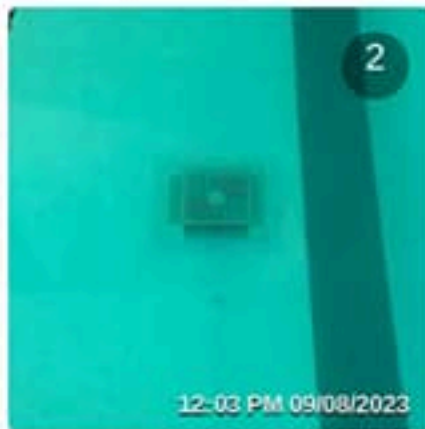
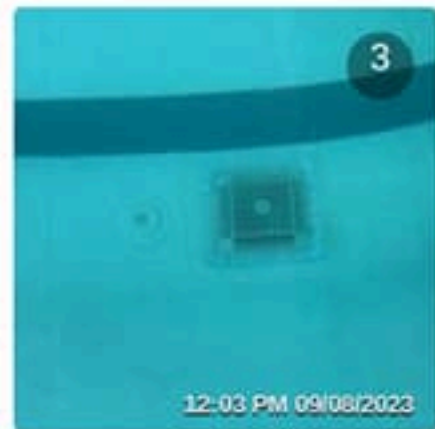
Main drains were visible in the deep area of the pool. Staff reports these drains are not functioning.

- 10) Main drains are not functioning.
- 11) Bulb replacement is needed on two overhead lighting fixtures.
- 12) Piping hangers in subgrade mechanical chase are severely corroded.

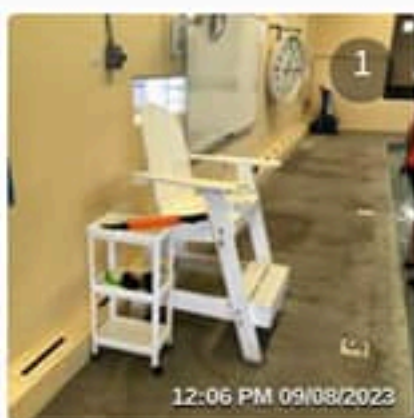
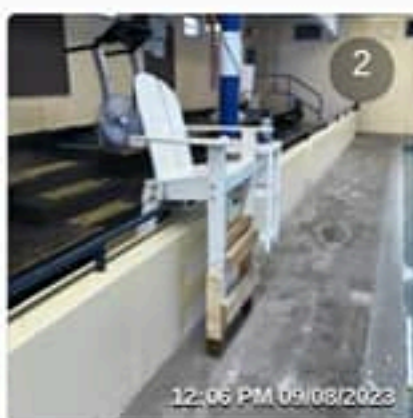
Lifeguard station

Two lifeguard chairs were present and in use

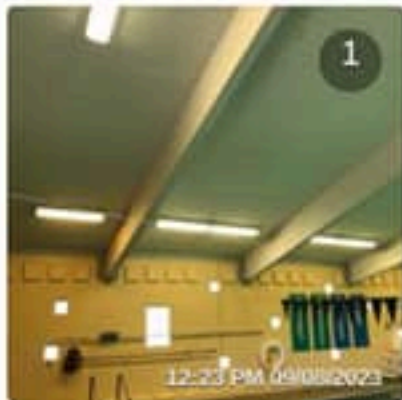
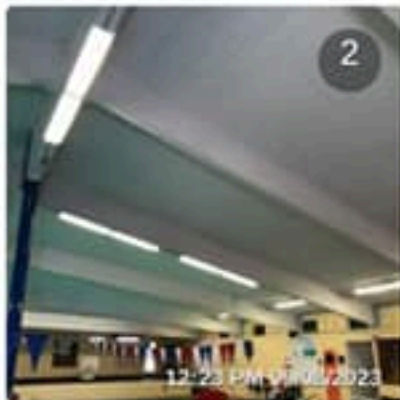
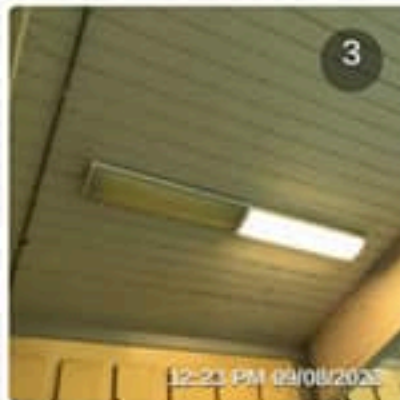
Lighting

Pool does not have underwater lighting.

Overhead natatorium lighting was dim but not insufficient. Two overhead lights were observed to be out and in need of bulb replacement

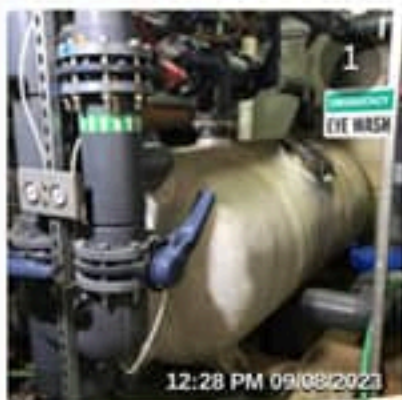
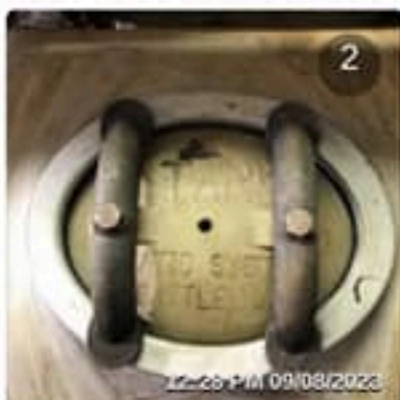
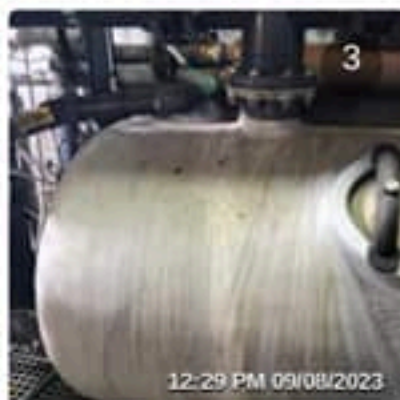
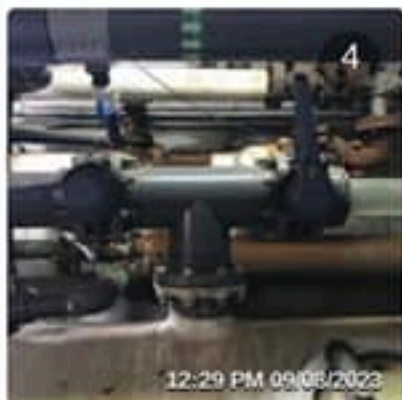
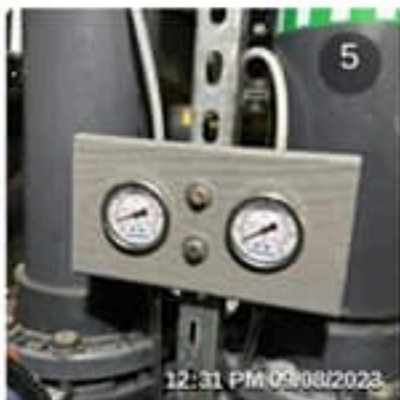
Filtration

Pool is filtered with a single tank horizontal sand filter. Backwash valves are operated manually.

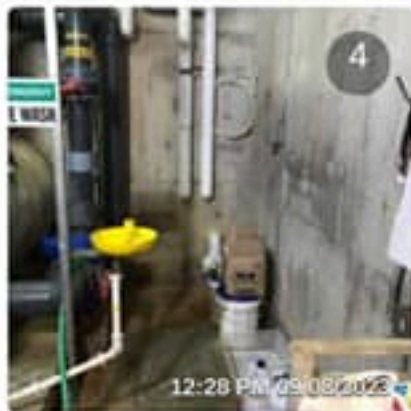
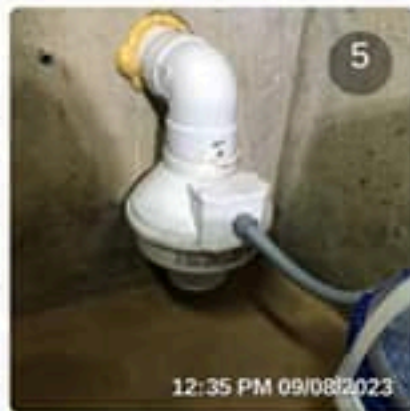
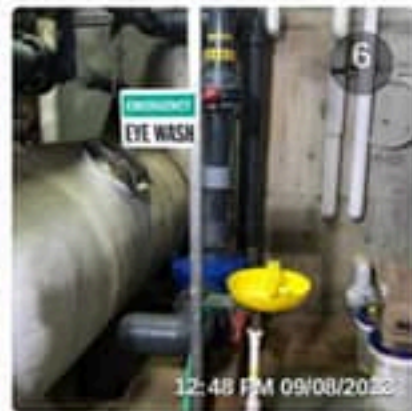
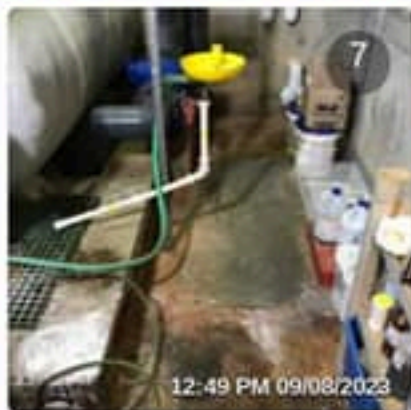
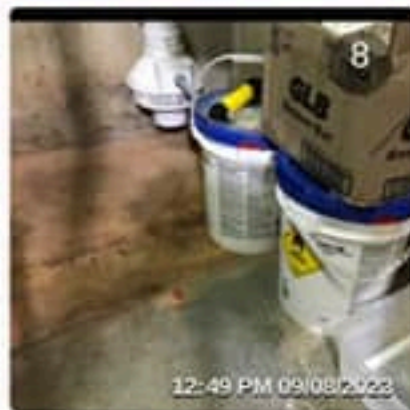
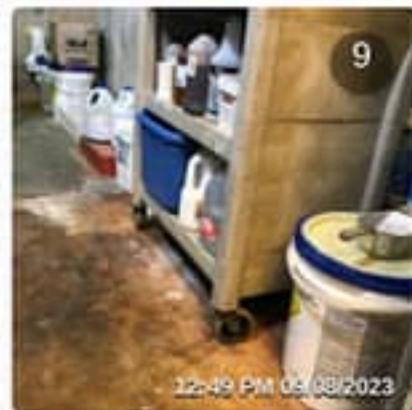
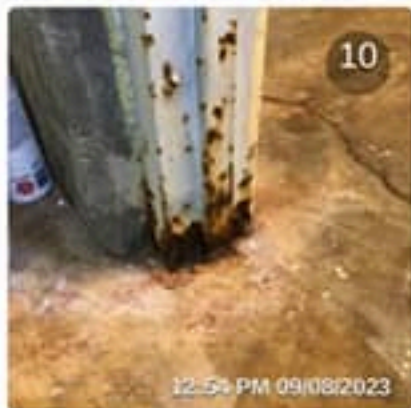
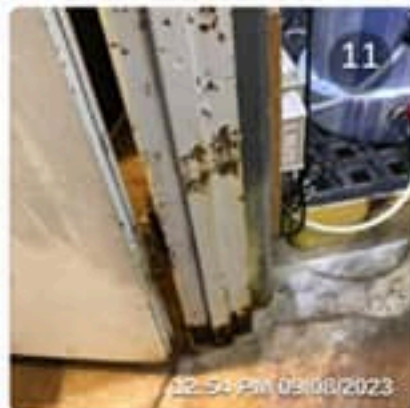
Water from the pool gutters is conveyed to a surge tank in the mechanical room. The surge tank has open venting to the mechanical room, thus allowing corrosive humidity and chloramines from the pool water to enter the mechanical room. The concrete top of the surge tank is badly deteriorated with exposed and corroded rebar.

- 15) Chemicals storage lacks separation of hazardous compounds.
- 16) Surge tank concrete is deteriorating.
- 17) Pool heat exchanger is excessively corroded.

- Install Ultraviolet
Install an ultraviolet disinfection system for chloramine reduction and additional pathogen protection.
- Repair Surge Tank
Repair deteriorating concrete on surge tank.

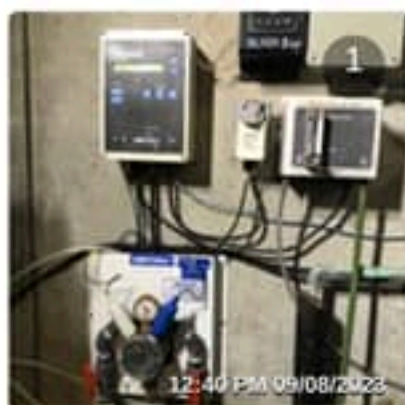
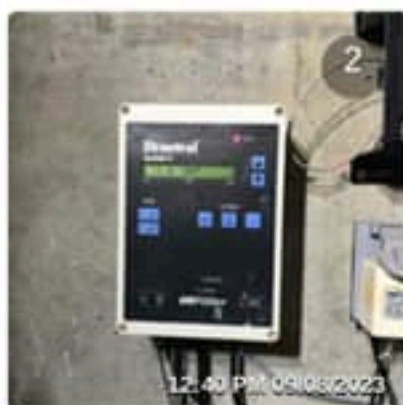
Water Level Controller

The water level in the surge tank is monitored and controlled with an electronic water level sensor.

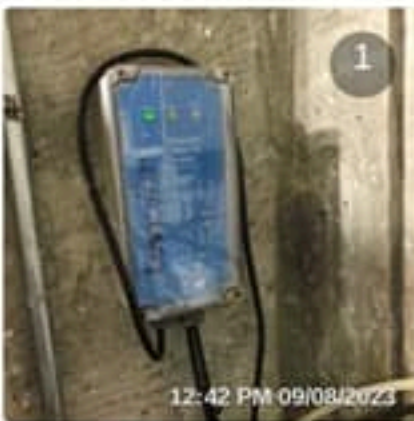
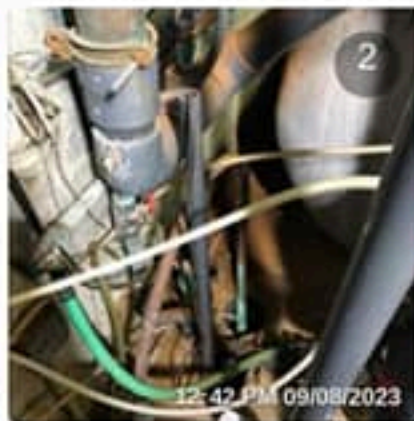
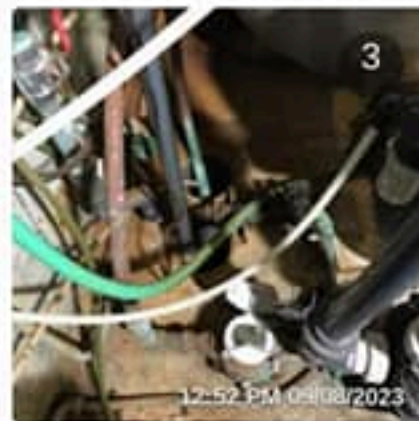
Flow Meter

Signet flow meter measures the flow rate with a sensor located on the pressure side of the pump.

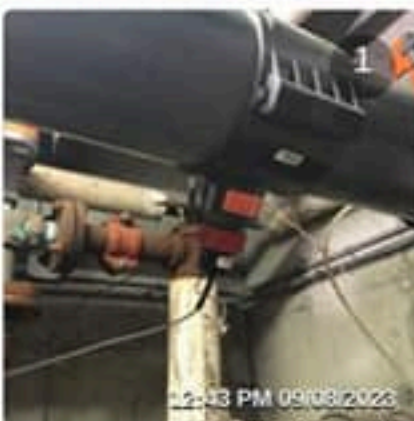
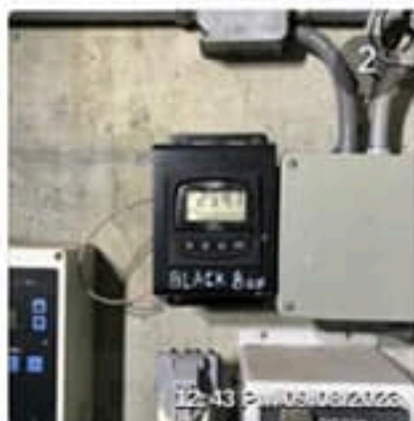
Chlorine Disinfection

Calcium hypochlorite is used to disinfect the pool with a Pulsar feeder system. Erosion feeder is placed on a spill containment pallet; however, spill containment pallet is full of clear liquid (presumed to be water) and therefore has no containment capacity. Booster pump circulates water through the feeder bypass piping and eroded chemical is injected into the circulation piping via venturi.

- 18) Chlorine feed system is improperly located and lacking effective spill containment.
- 19) Absence of secondary disinfection system

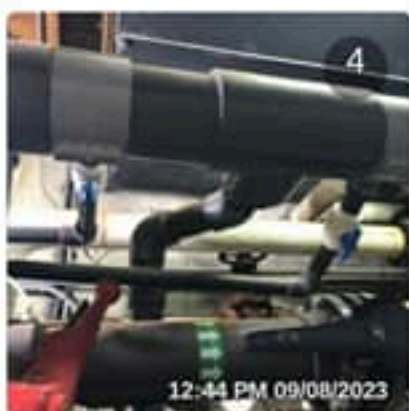
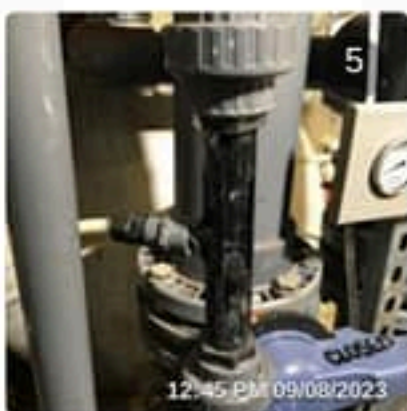
PH Control

The pool water pH is controlled with the injection of carbon dioxide. Bulk carbon dioxide is stored in a nearby general mechanical room. Carbon dioxide controller had a difficult to read rate of flow indicator due to dirt/buildup in the sight tube. During the observation the unit could be heard switching on/off.
